PROLIANCE TECH TIP

RADIATOR 432192 1986-1995 2.5L, 3.0L and 3.8L Taurus / Continental / Sedans and Wagons

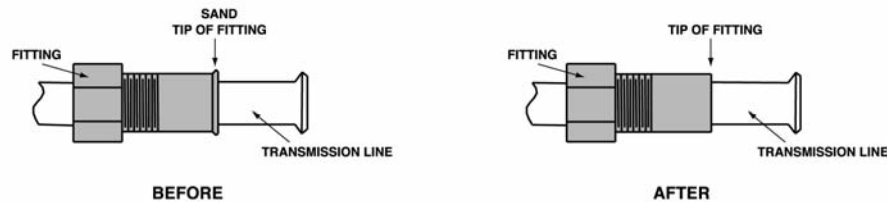
You may encounter difficulty in installing your transmission oil cooler line fitting into the enclosed oil cooler adapters. If this does occur, **do not return the radiator**, as the problem exists with your transmission oil cooler line fitting. It has been re-sized due to previously being over tightened into the original adapter.

5. Cover transmission line opening to prevent metal chips from contaminating transmission fluid.
6. Use a fine grade of sandpaper (220-240 Grit) and rotate around the tip of the fitting (the part that was slid back in step 4) to remove resized material. Do not sand the tip of the transmission line.

7. Check to see if fitting now engages adapter. If not, repeat step 6 above until fitting engages adapter.
8. When fitting does engage adapter proceed with radiator installation.

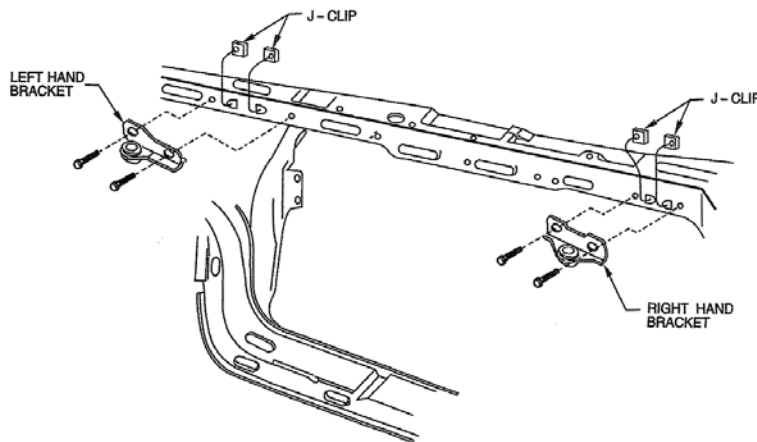
FIGURE IS FOR THE INSTALLATION OF RADIATORS FOR THE 1986-1995 2.5L, 3.0L AND 3.8L TAURUS/SABLE/CONTINENTAL SEDANS AND WAGONS WHEN THE BRACKETS ARE REQUIRED TO CHANGE THE MOUNTING POINTS OF THE RADIATOR FROM PIN MOUNT TO BUSHING MOUNT.

1. ALL 3.8L TAURUS/SABLES AND CONTINENTALS BUILT BEFORE NOVEMBER 1, 1988 WILL REQUIRE ENCLOSED BRACKET KIT.
2. ALWAYS BE SURE TO INSTALL ALL FOUR J-CLIPS AND BOLTS.
